OH-13 AND OH-23 ACCIDENT SUMMARY

1 July 1966 through 30 June 1967

by
P. R. Thompson

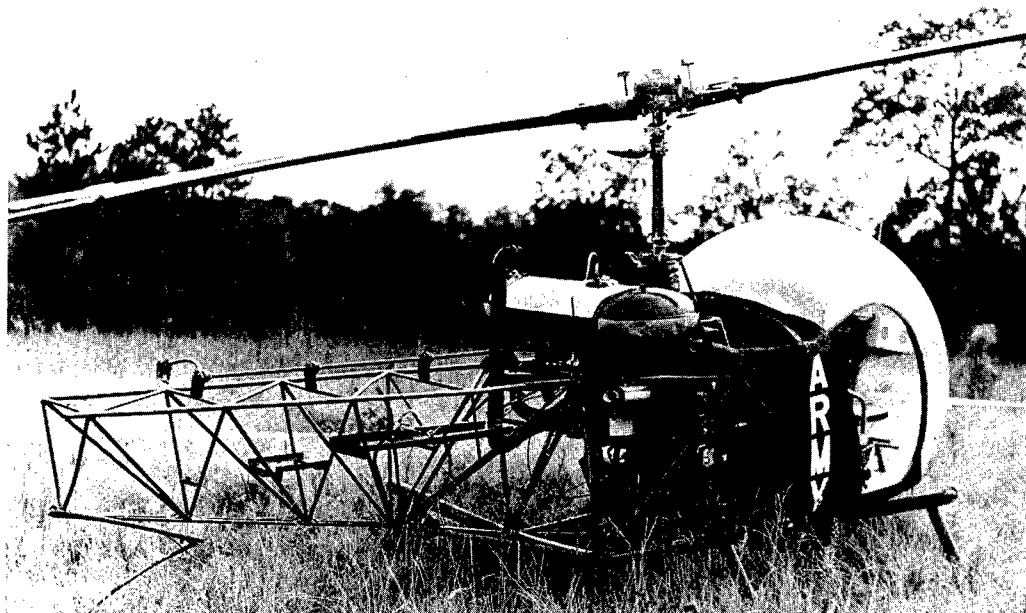
F567-RPM was lost during landing approach. Full throttle was added, collective pitch pulled, and aircraft flared, but rpm could not be regained. Aircraft entered high sink rate and full collective pitch was pulled at 10 feet to cushion landing. Aircraft hit on heels of skids, tail guard, and ventral fin, and bounced forward, with a main rotor blade flexing and severing tail boom. It then skidded left and settled to ground, damaging cross tubes, skid tubes, center frame, cabin, and tail rotor. Caused by allowing rpm to dissipate because of slow cross check, using improper technique for correcting low rotor rpm, and placing aircraft in high sink rate by flaring without completely lowering collective pitch.

F567
RPM was lost and aircraft entered high sink rate. Improper technique was used for correcting low rotor rpm.

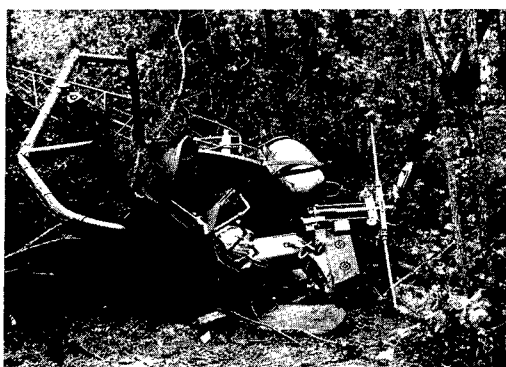
G791
Aircraft settled and struck trees due to loss of translational lift. Poor quality control and inadequate maintenance supervision were factors.

G791—Downwind takeoff was made from confined area. Aircraft settled after clearing trees, struck trees, and crashed. Pilot was killed and aircraft destroyed. Caused by (1) loss of translational lift, (2) lack of quality control, and (3) inadequate maintenance supervision. Maintenance records for the 6-month period preceding the accident revealed that numerous partial and ineffective corrective maintenance actions had been taken without apparently correcting (1) continual magneto troubles due to improper timing, which caused a rough running engine, possible preignition and/or detonation; excessive cylinder head and oil temperatures; and lack of power; (2) continual trouble with No. 2 cylinder, ranging from bent push rods to "O" compression; (3) excessive oil consumption (No. 4 piston was changed because of engine throwing oil); (4) excessive smoke from right exhaust after starting; (5) fluctuating oil pressure; and (6) high cylinder head and oil temperatures. Engine teardown analysis revealed that engine was incapable of producing maximum power for high performance takeoff. Analysis also revealed loss of compression in three cylinders, magnetos out of time, loose spark plugs, and burnt piston rings. Iron content in engine oil had risen from 23 to 75 parts per million during 12-hour period before accident.

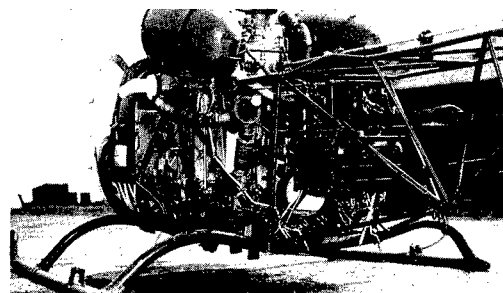
G266 Improper removal and installation of tail rotor gearboxes due to poor supervision.

G266—Loud pop was heard during hover, left pedal hit stops, and aircraft turned right. Pitch was reduced to full “down” position and aircraft struck ground, damaging cross tubes. A whip action of the tail boom caused tail boom assembly to bend at upper left attaching point. Caused by improper removal and installation of tail rotor gearboxes.

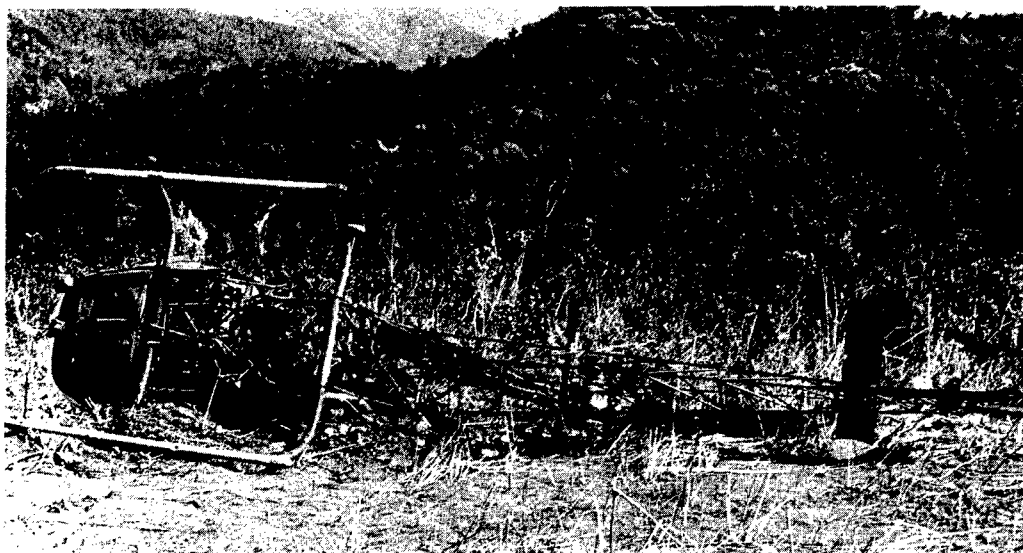
020501—Approach was made to hover and observer cleared tail rotor. Left skid was placed on ground and, as right skid was lowered, aircraft tipped right. Full left cyclic was applied, but aircraft continued to tip until main rotor struck ground. Pilot and observer escaped through broken bubble. Aircraft caught fire and burned. Caused by (1) allowing aircraft to tip too far for recovery, (2) landing on rough slope, (3) unimproved LZ, and (4) lack of provisions for ground guides.

020501
Attitude got beyond recovery and aircraft was landed on rough slope. Pilot was relatively inexperienced and there was no improved LZ's or provisions for ground guides.

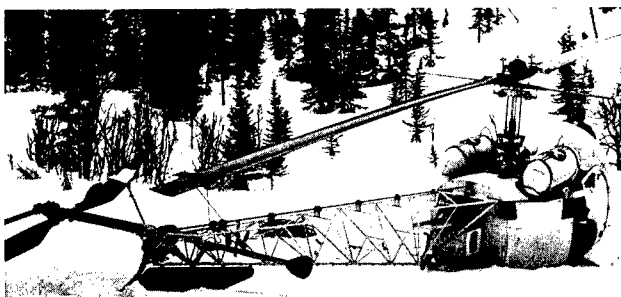
031709 Tail rotor struck tree. Suspect blowing snow prevented accurate judgment of hover height and hovering turn allowed tail rotor to swing upslope.

deep snow while passenger got out to remove flag-pole. Takeoff was made and area orbited until flag-pole was removed. Aircraft was then landed to pick up passenger. As aircraft was brought to hover during takeoff, left turn was made and tail swung into upslope, striking tree, damaging tail rotor blade, and severing tail rotor drive shaft. Aircraft began uncontrollable right turn, throttle was closed, and hovering autorotation was made. Caused by allowing tail rotor to strike tree. Suspect blowing snow prevented accurate judgment of hover height and turn allowed tail rotor to swing upslope.

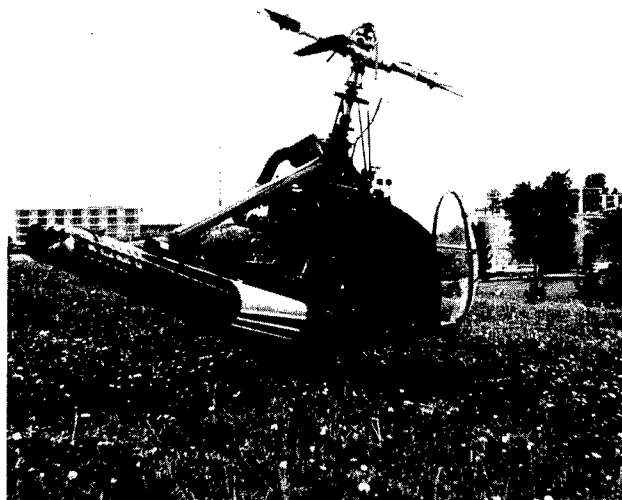
F480 Application of excessive pitch during takeoff over low wires.

F480—RPM dropped rapidly during takeoff and aircraft settled, struck sloping area on right skid, and tilted left. Skids folded under and main rotor blade warped downward, cutting away 4 feet of tail boom. Pilot sustained minor injuries. Caused by application of excessive pitch.

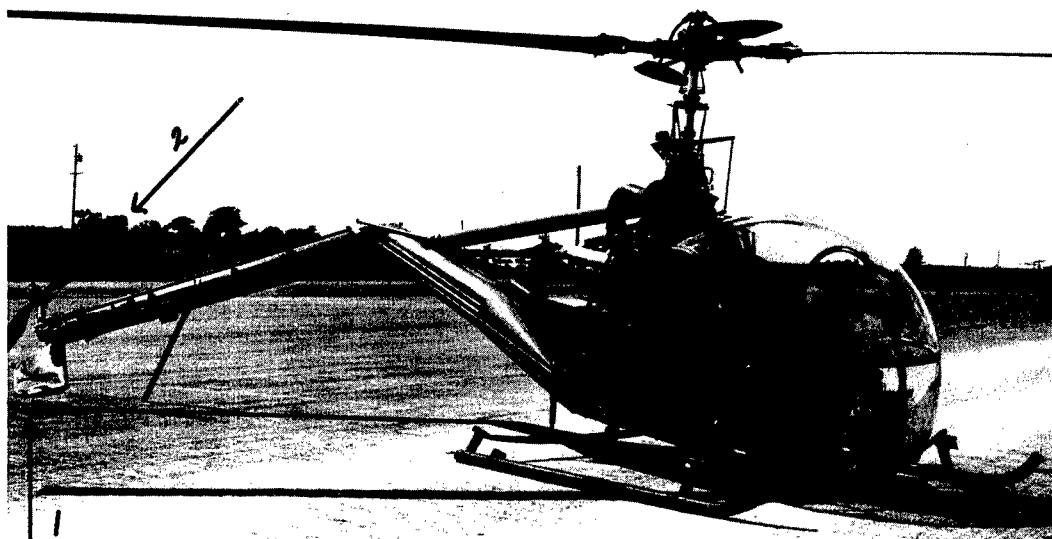
G290
SP bottomed collective and IP failed to recover. IP was relatively inexperienced and violated training directive.

G290—SP was hovering through parking area to takeoff panel. IP cut throttle for simulated forced landing and SP bottomed collective. IP was unable to recover and aircraft landed hard, damaging tail boom, cross tubes, airframe, lower beacon, stabilizer, 1-inch drive shaft, and hanger bearing. Caused by (1) bottoming collective, (2) inability of IP to recover, and (3) violation of training directive.

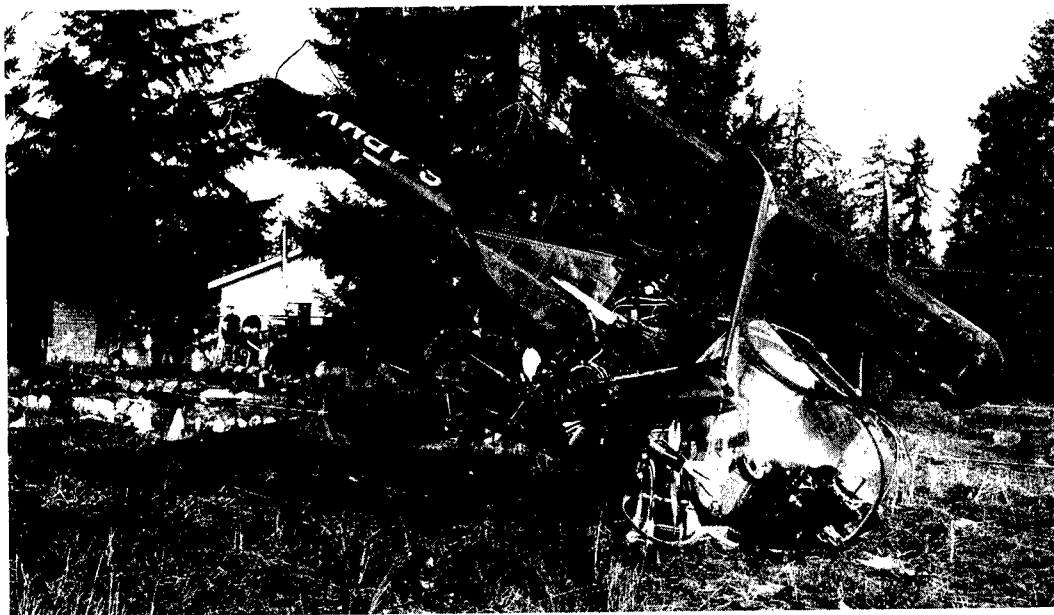
013001
Engine failed due to failure of No. 6 connecting rod assembly. An extensive maneuver was performed during approach due to powerlines and touchdown groundspeed was excessive.
